# V1910-CMW520-R1513P50 Release Notes

Comware software, Version 5.20, Release 1513P50

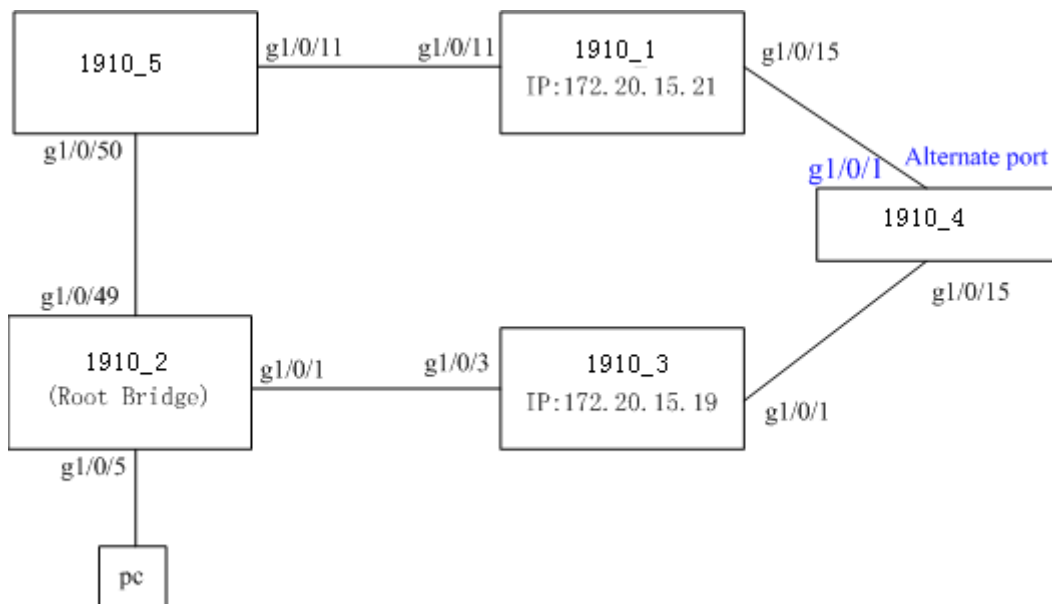
### LSD44945

- Symptom: In the following network diagram, a ping operation from the PC to 1910\_1 experiences a 30-second interruption.
- Condition: This symptom might occur when the following conditions exist:
  - All 1910 switches and the PC are in the same subnet.
  - MSTP is configured to avoid loops and all 1910 switches belong to MSTP instance 0.
  - The port G1/0/49 of the root bridge 1910\_2 is shut down.

- Workaround: Configure the **stp no-agreement-check** command on the root ports.
