A5800_5820X-CMW520-R1808P08 Release Notes

This document describes the features, restrictions and guidelines, open problems, and workarounds for version A5800_5820X-CMW520-R1808P08. Before you use this version in a live network, back up the configuration and test the version to avoid software upgrade affecting your live network.

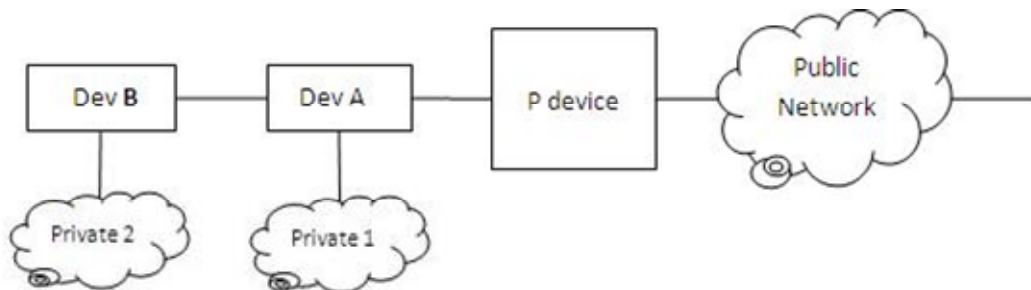
LSD67497

- Symptom: The switch cannot learn PIM RP and NBR information in a VPN when it acts as a PE.
- Condition: This symptom might occur when the switch acts as a PE that resides in the same position as Dev B in the following network. In this network, multicast VPN is enabled. For network Private 1, Dev A is a PE device. For network Private 2 and Dev B, Dev A is a P device. Dev A can receive VPN PIM RP and NBR information from the upstream device but it does not advertise the information to Dev B.
